**Eagle Picher
Ohio, Michigan, and Illinois Properties
TDD: S05-0603-003**

Site Inspection Reports

**Subject: Site Inspection Reports
Eagle Picher Ohio/Michigan/Illinois Properties
Technical Direction Document No. S05-0603-003
Tetra Tech Contract No. 68-W-00-129**

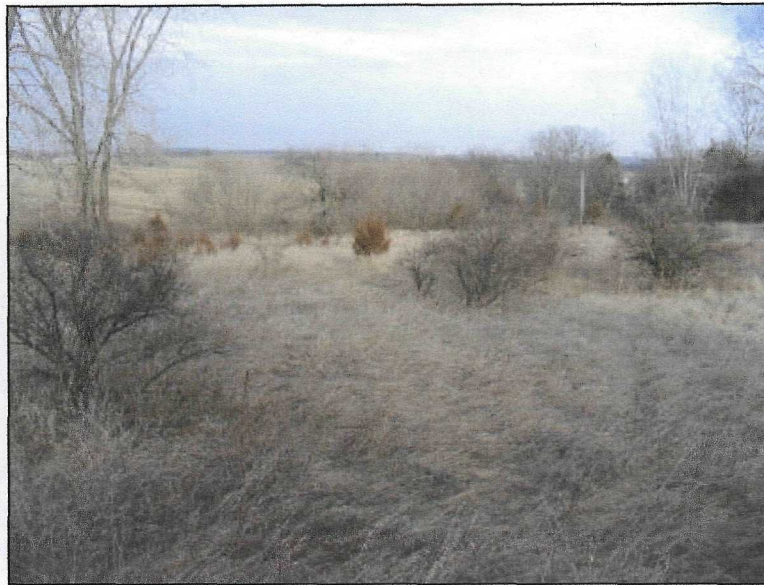
Photograph No. 1 **Date:** March 15, 2006
TDD No.: S05-0603-003 **Orientation:** East
Location: Galena, Illinois
Subject: South area of the former concrete pad and subject site southern property boundary

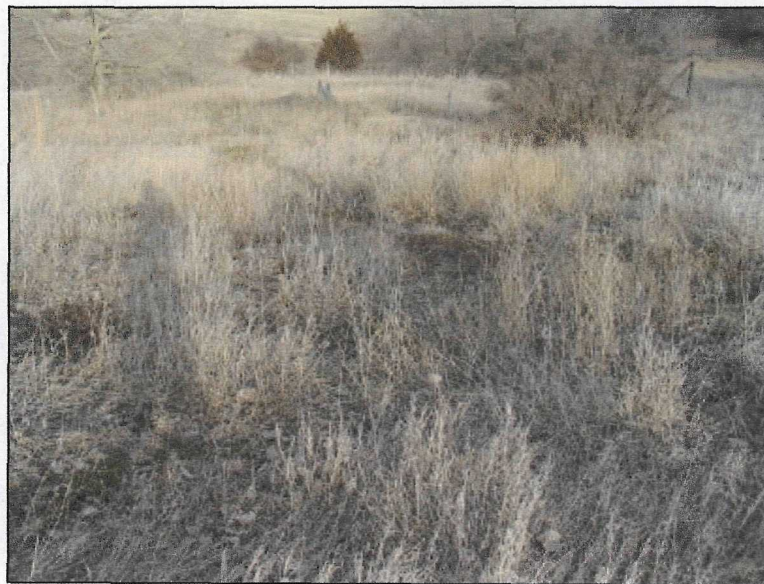
Photograph No. 2 **Date:** March 15, 2006
TDD No.: S05-0603-003 **Orientation:** East
Location: Galena, Illinois
Subject: Northeastern part of former concrete pad where runoff water would have traveled. Bare ground and moss visible.

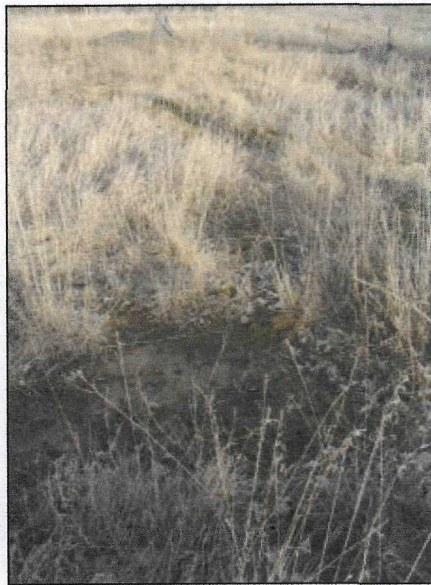
Photograph No. 3 **Date:** March 15, 2006
TDD No.: S05-0603-003 **Orientation:** East
Location: Galena, Illinois
Subject: Close-up of bare ground and moss area

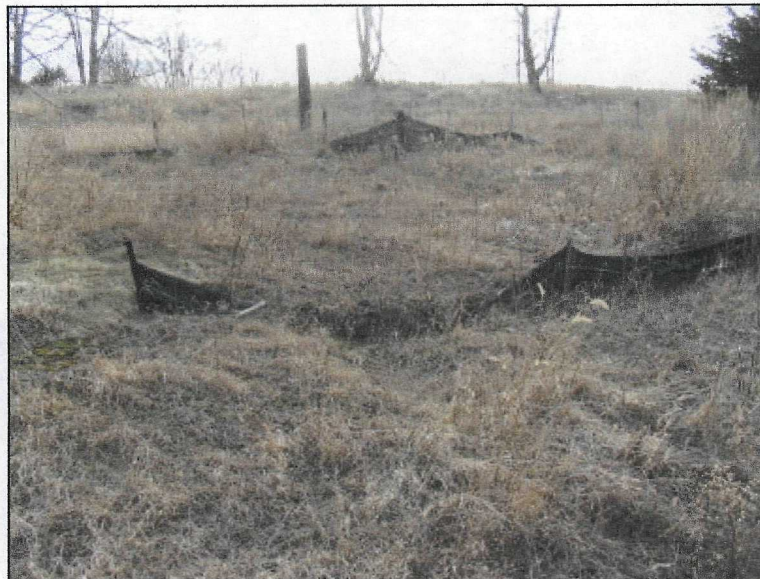
Photograph No. 4 **Date:** March 15, 2006
TDD No.: S05-0603-003 **Orientation:** South
Location: Galena, Illinois
Subject: Bare ground east of former concrete pad. Silt fences showing signs of soil transport.

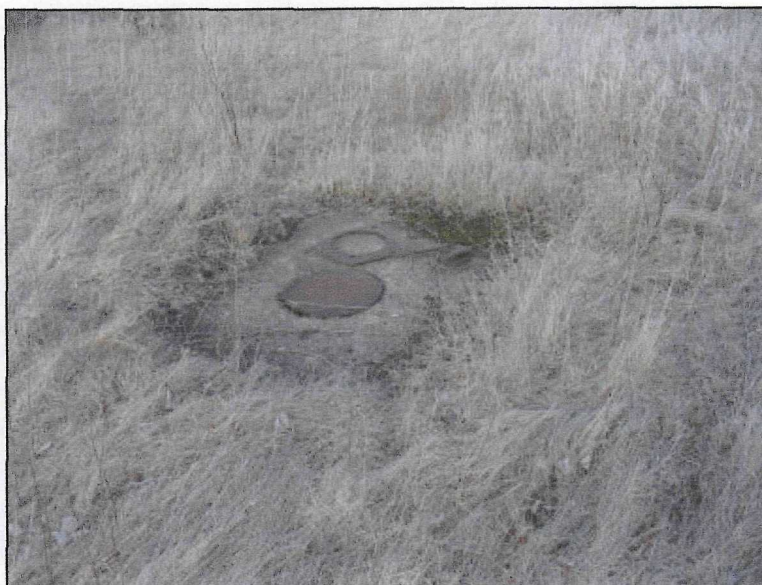
Photograph No. 5 **Date:** March 15, 2006
TDD No.: S05-0603-003 **Orientation:** North
Location: Galena, Illinois
Subject: Former air shaft left from the mine.

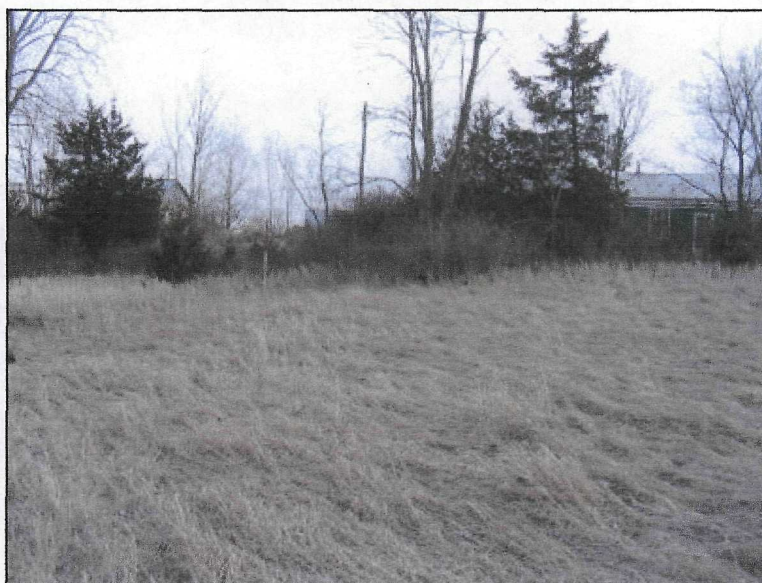
Photograph No. 6 **Date:** March 15, 2006
TDD No.: S05-0603-003 **Orientation:** South
Location: Galena, Illinois
Subject: Vertical pipe in center of picture is part of a septic system from the former mine office or former residence.

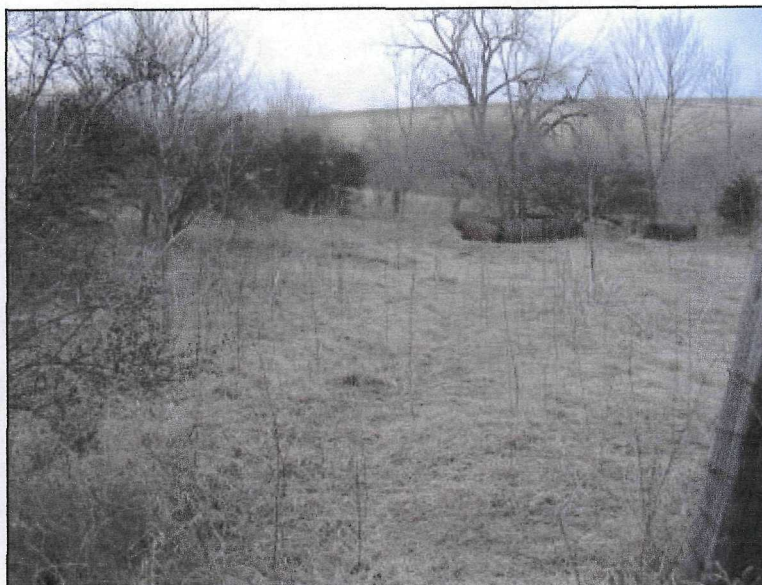
Photograph No. 7 **Date:** March 15, 2006
TDD No.: S05-0603-003 **Orientation:** NE
Location: Galena, Illinois
Subject: Empty steel barrel drums.

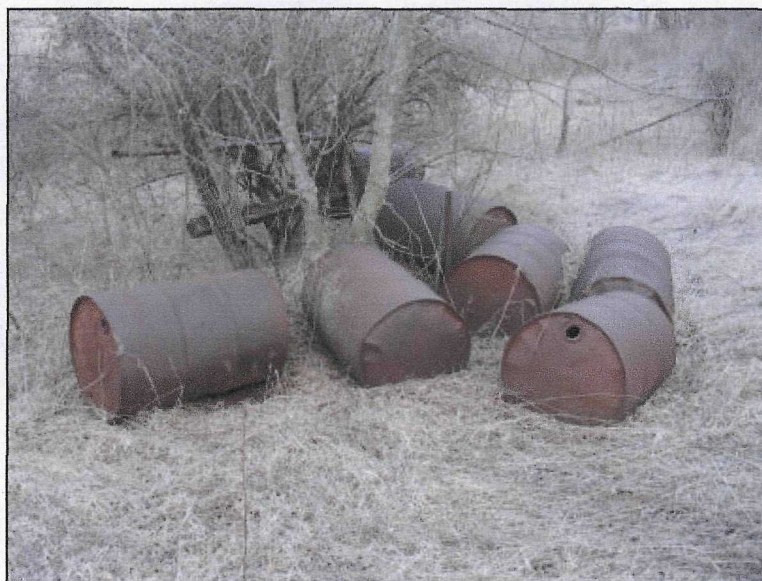
Photograph No. 8 **Date:** March 15, 2006
TDD No.: S05-0603-003 **Orientation:** East
Location: Galena, Illinois
Subject: Close-up of the empty steel drums

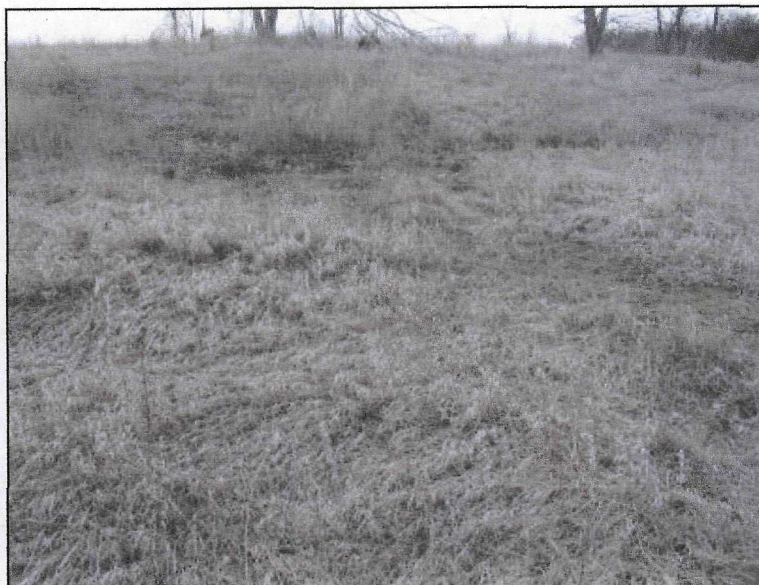
Photograph No. 9 **Date:** March 15, 2006
TDD No.: S05-0603-003 **Orientation:** West
Location: Galena, Illinois
Subject: Bare ground and moss in drainage pathway from the former concrete pad

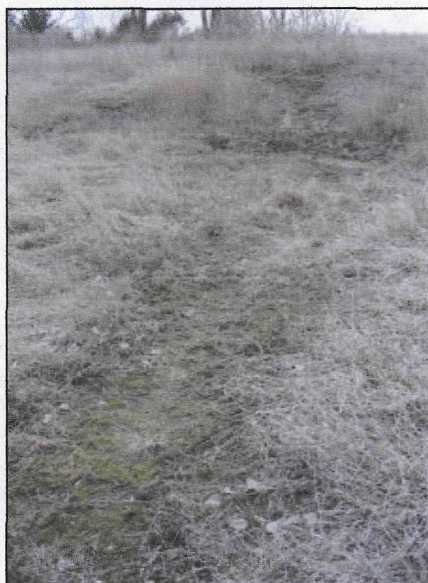
Photograph No. 10 **Date:** March 15, 2006
TDD No.: S05-0603-003 **Orientation:** West
Location: Galena, Illinois
Subject: Drainage pathway from the former concrete pad

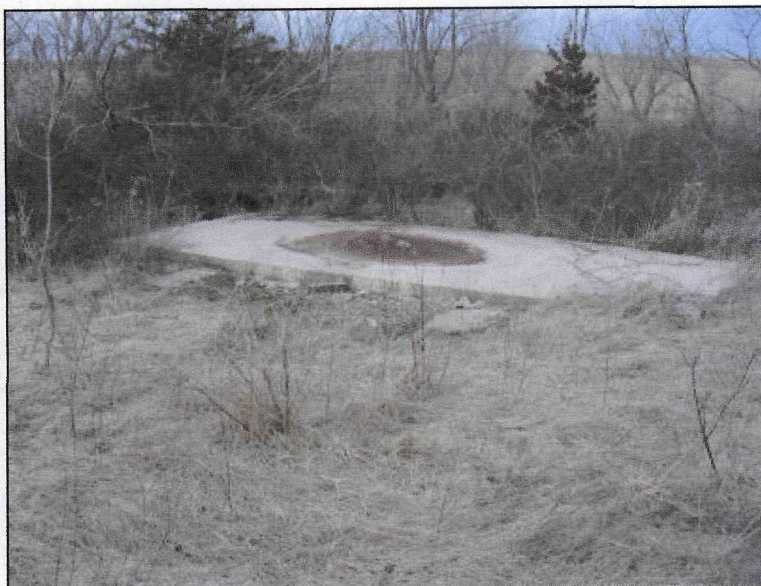
Photograph No. 11 **Date:** March 15, 2006
TDD No.: S05-0603-003 **Orientation:** North
Location: Galena, Illinois
Subject: Concrete slab located NE of the former concrete pad storage area. Purpose is unknown; however it may be a cover for a mine shaft.

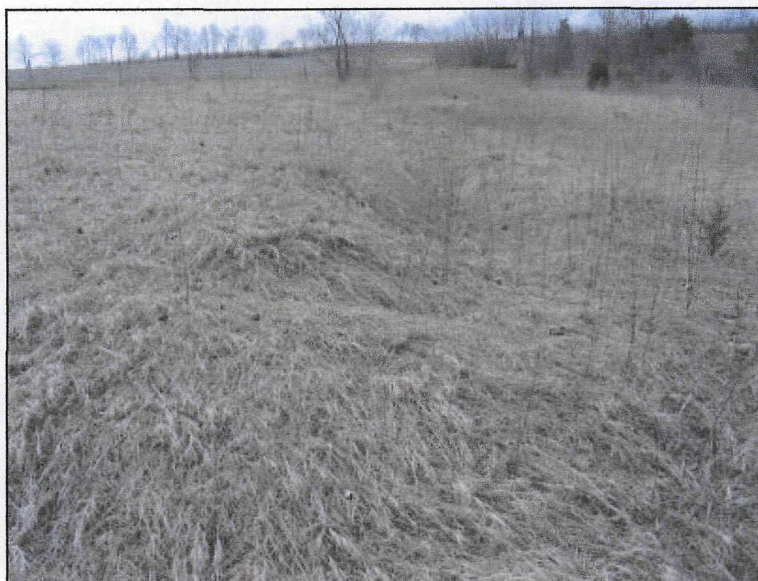
Photograph No. 12 **Date:** March 15, 2006
TDD No.: S05-0603-003 **Orientation:** North
Location: Galena, Illinois
Subject: Uneven bumpy terrain northwest of the former concrete pad

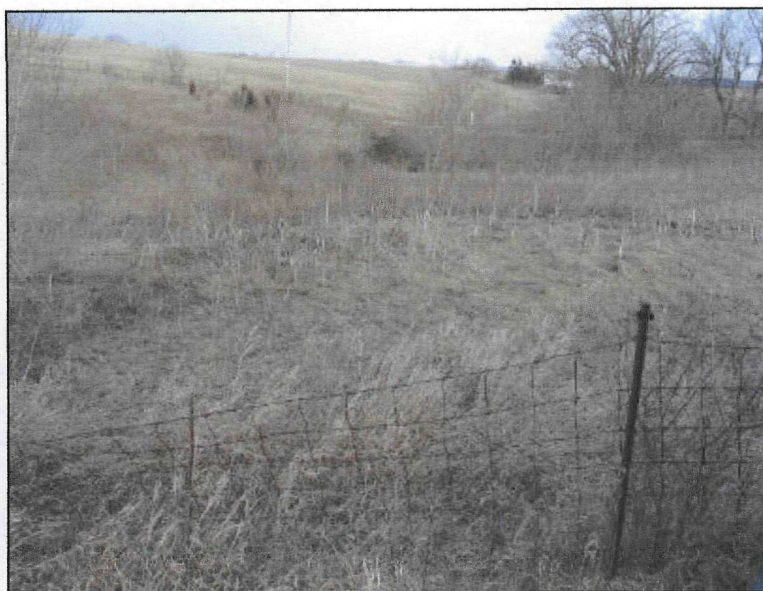
Photograph No. 13 **Date:** March 15, 2006
TDD No.: S05-0603-003 **Orientation:** Northeast
Location: Galena, Illinois
Subject: Slope down to drainage area (dry unnamed creek bed). This area was not remediated since it is not in the drainage pathway from the former concrete pad storage location.

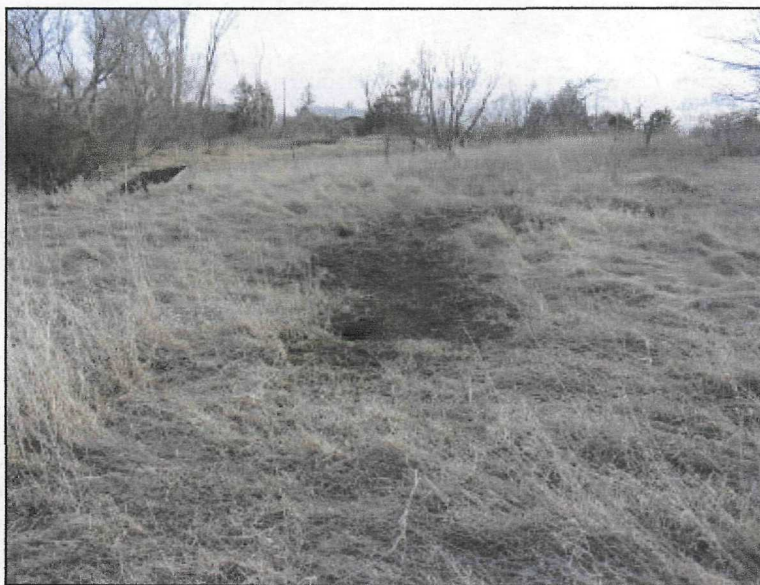
Photograph No. 14 **Date:** March 15, 2006
TDD No.: S05-0603-003 **Orientation:** South
Location: Galena, Illinois
Subject: Bare ground east of former concrete storage pad area.

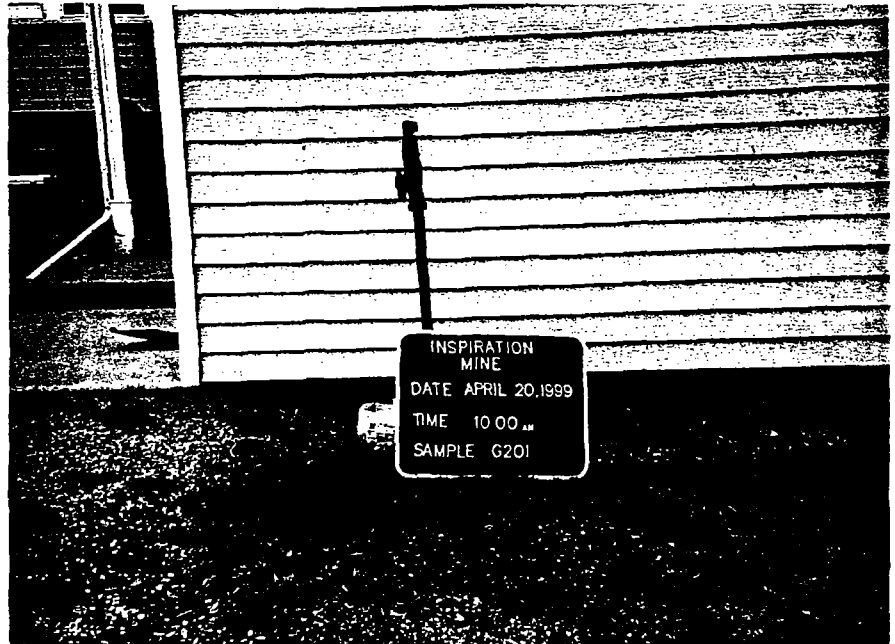
COMMENTS: Photo taken of residential ground water well west of mine. Timme property.

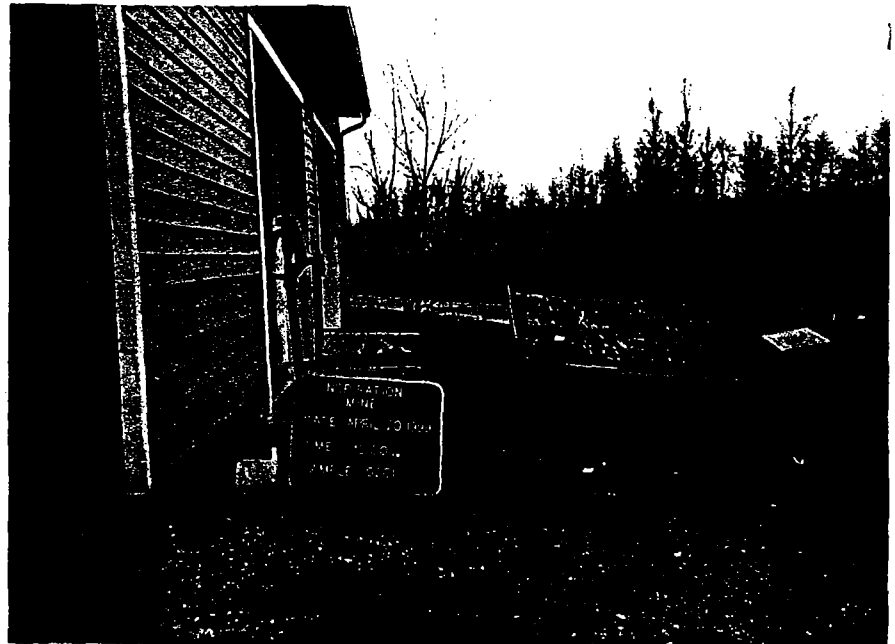
COMMENTS: Photo taken of residential ground water well west of mine. Timme property.

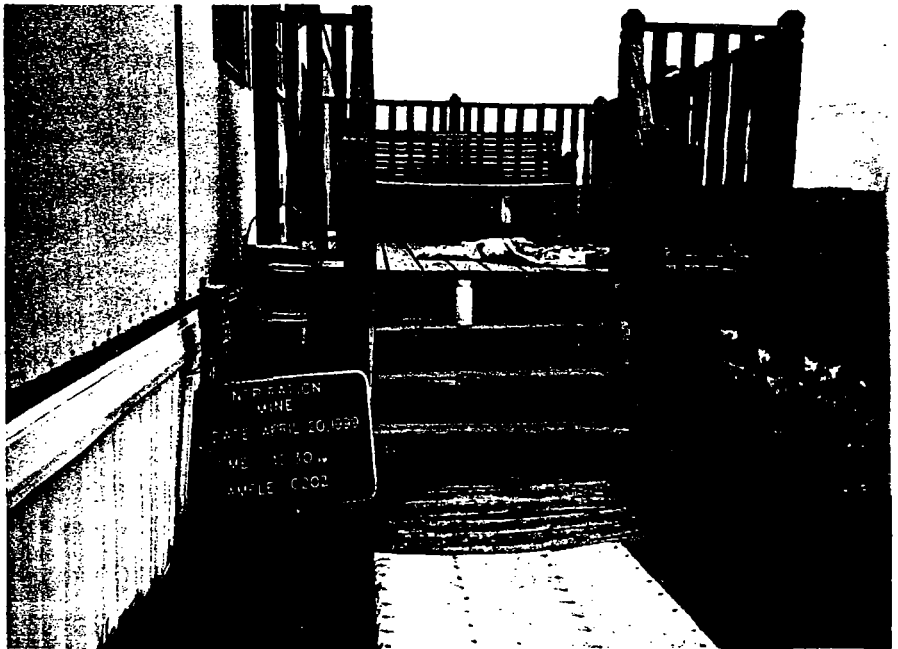
COMMENTS: Photo taken of residential ground water well located southeast of mine.

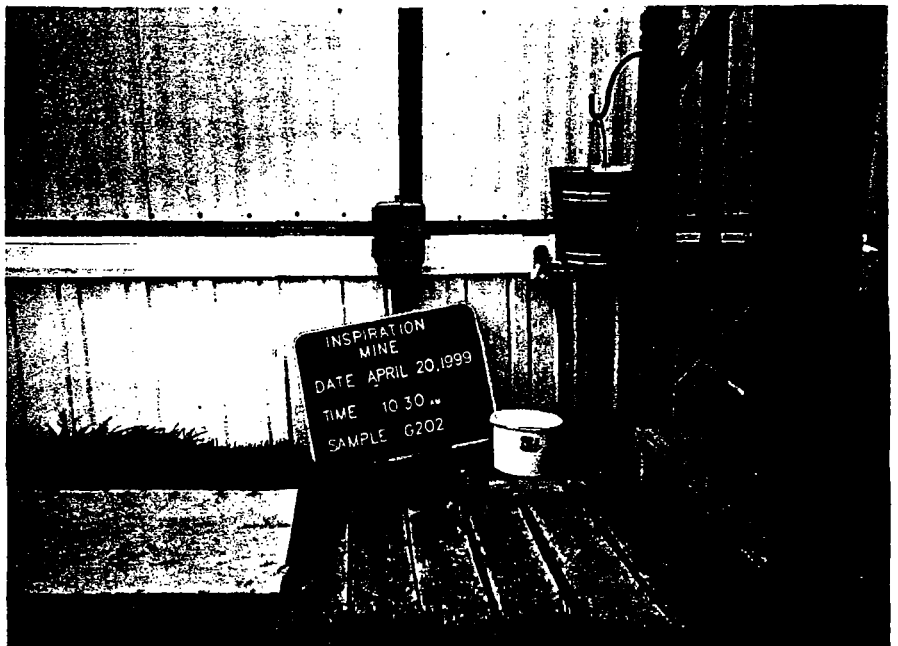
COMMENTS: Photo taken of residential ground water well located southeast of mine.

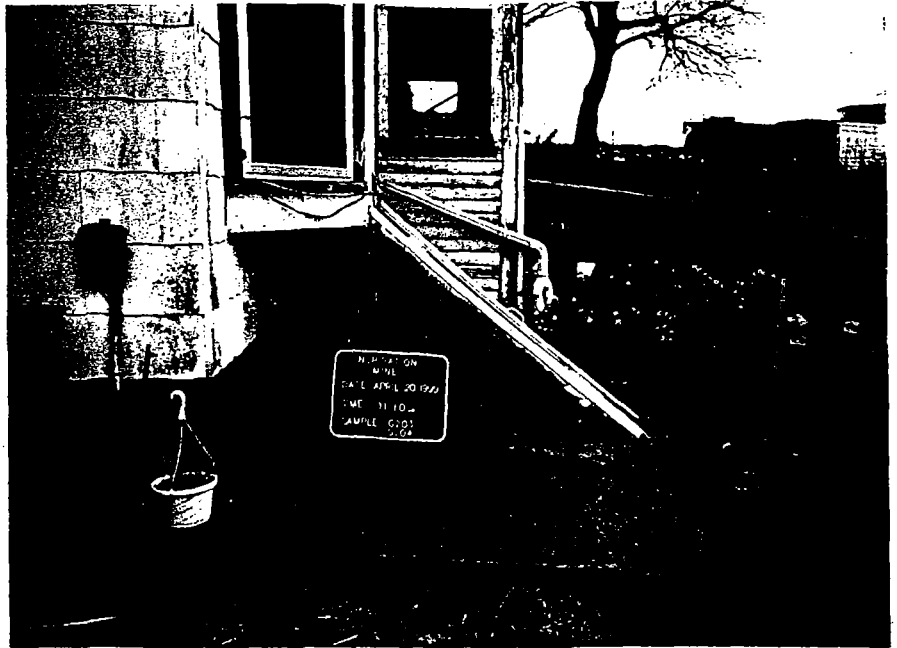
COMMENTS: Photo taken of residential ground water well east of mine. Gotto property.

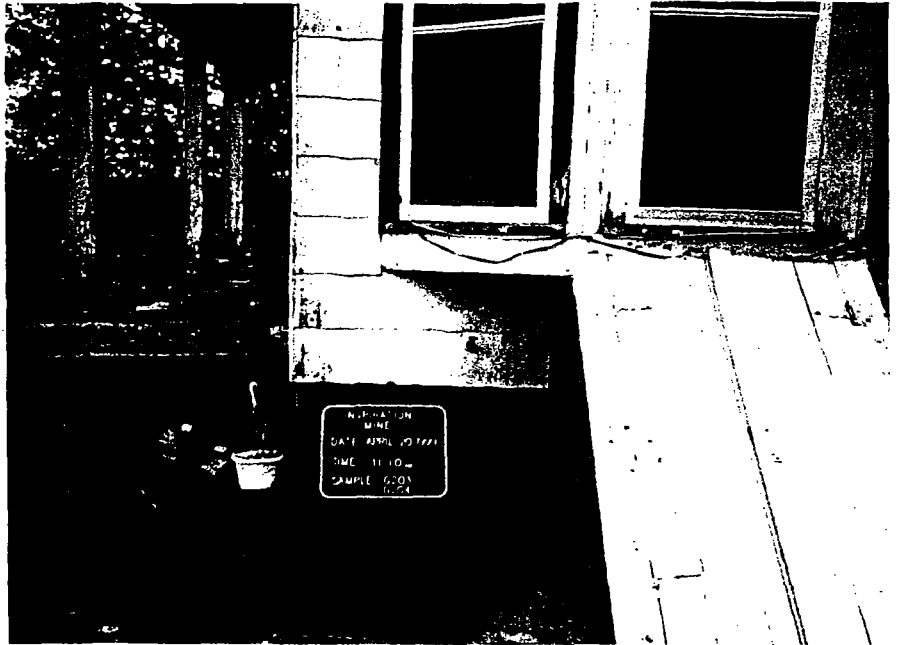
COMMENTS: Photo taken of residential ground water well east of mine. Gotto property.

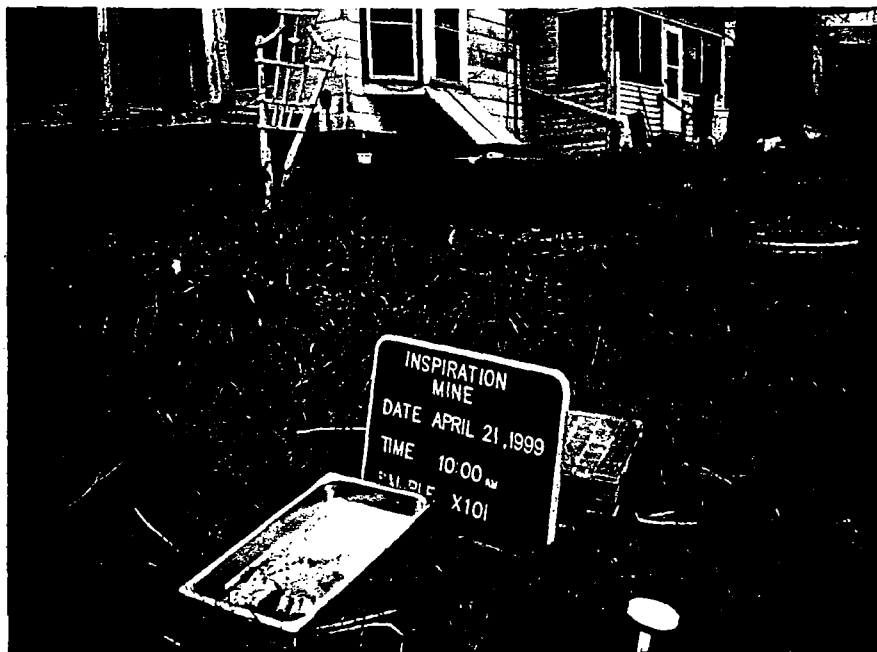
**COMMENTS: Photo taken
of residential soil
sample east of mine.**

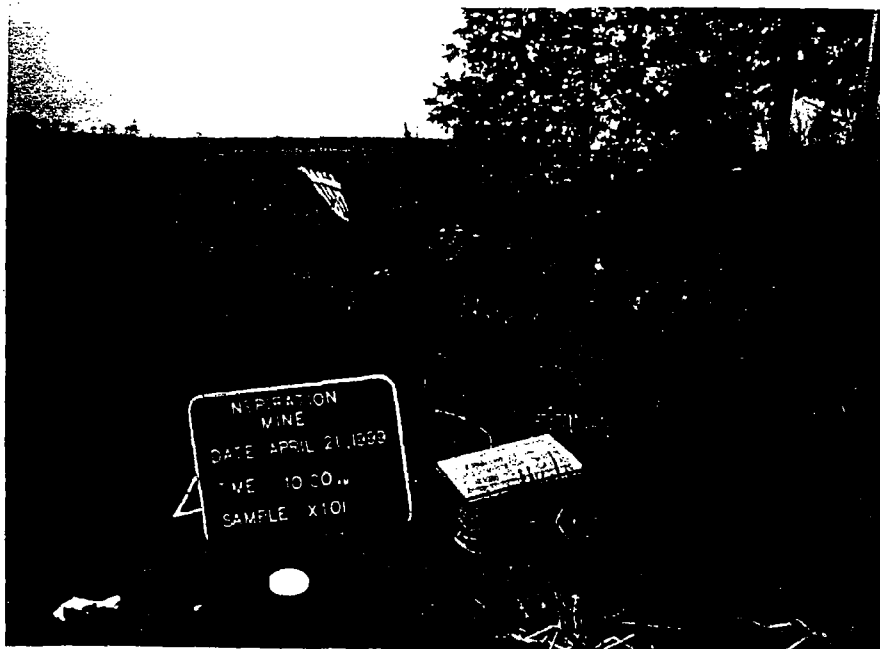
**COMMENTS: Photo taken
of residential soil
sample east of mine.**

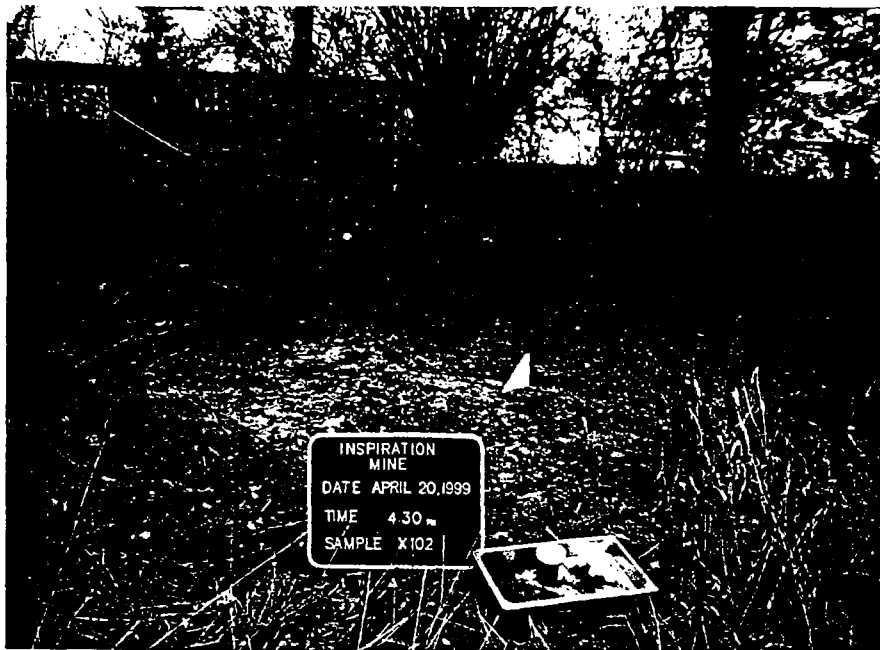
COMMENTS: Photo taken of soil sample in former lagoon area on mine property.

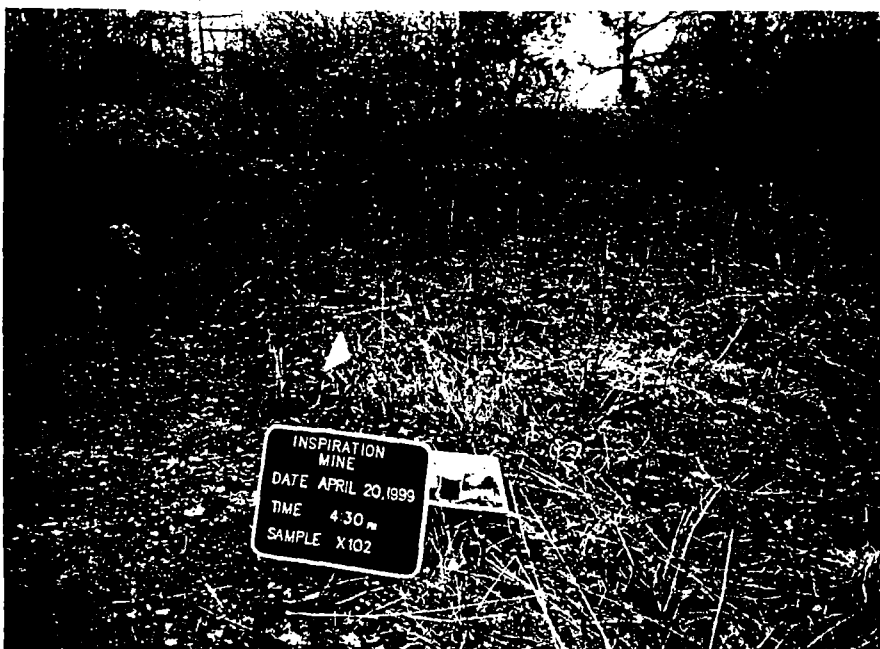
COMMENTS: Photo taken of soil sample in former lagoon area on mine property.

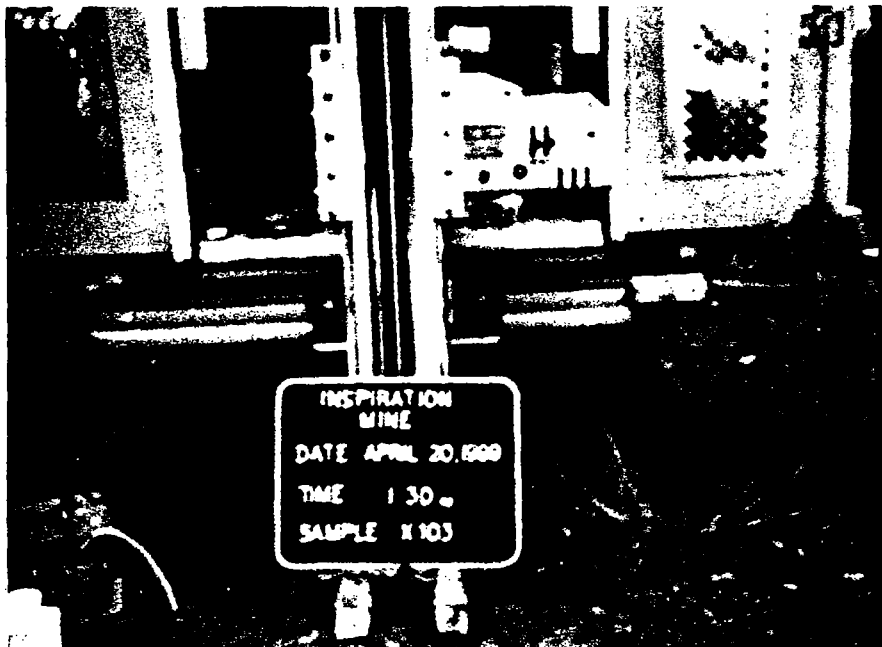
COMMENTS: Photo taken of soil sample collected by Agency Geoprobe in former lagoon area on mine property.

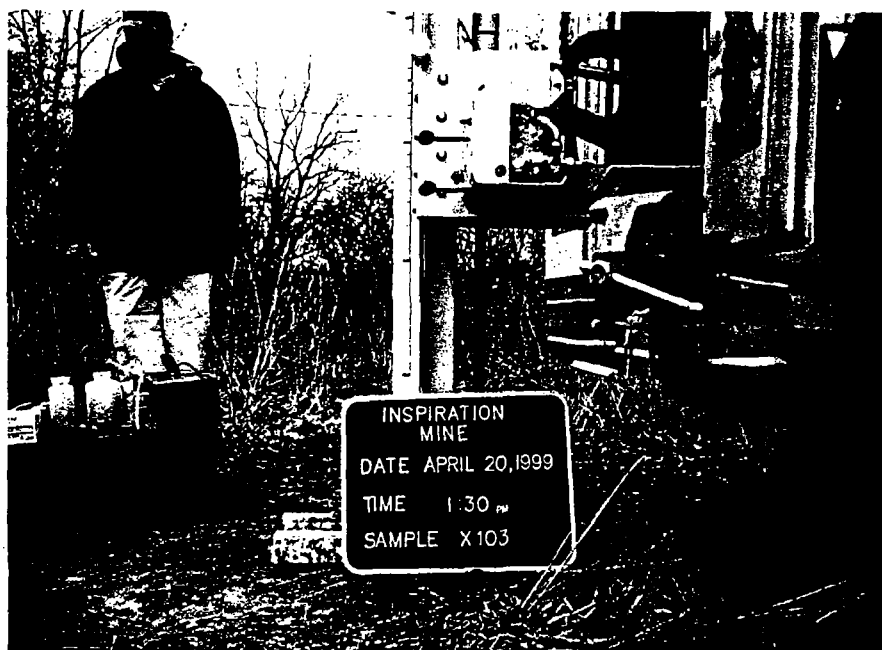
COMMENTS: Photo taken of soil sample collected by Agency Geoprobe on mine property.

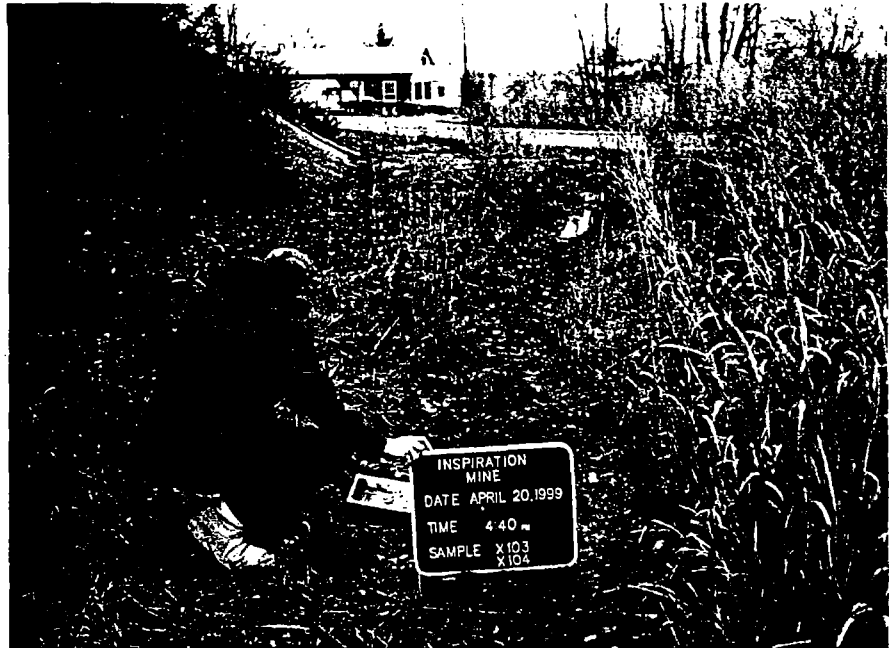
COMMENTS: Photo taken of soil sample east of former lagoon on mine property.

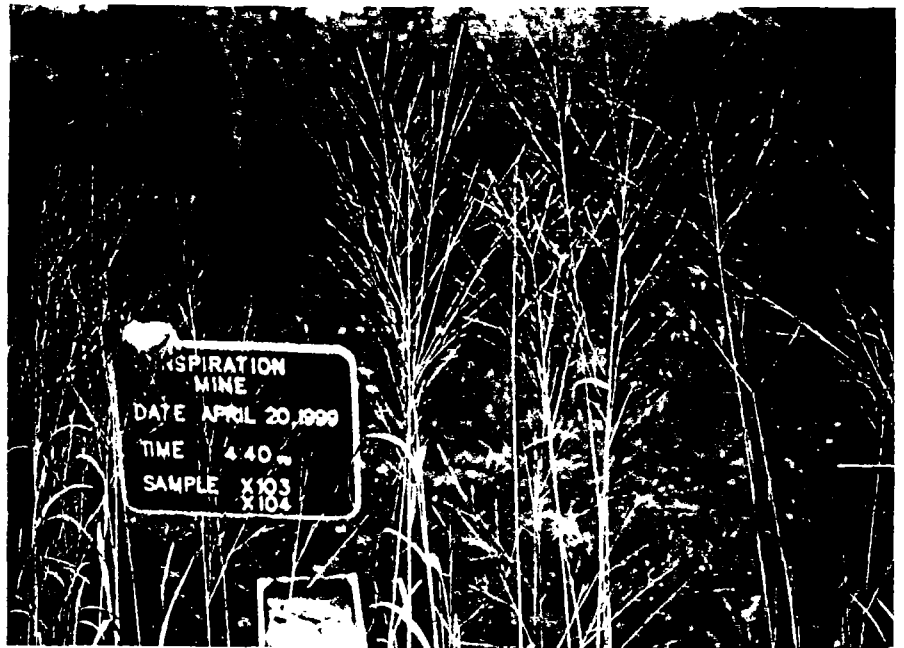
COMMENTS: Photo taken of soil sample east of former lagoon on mine property.

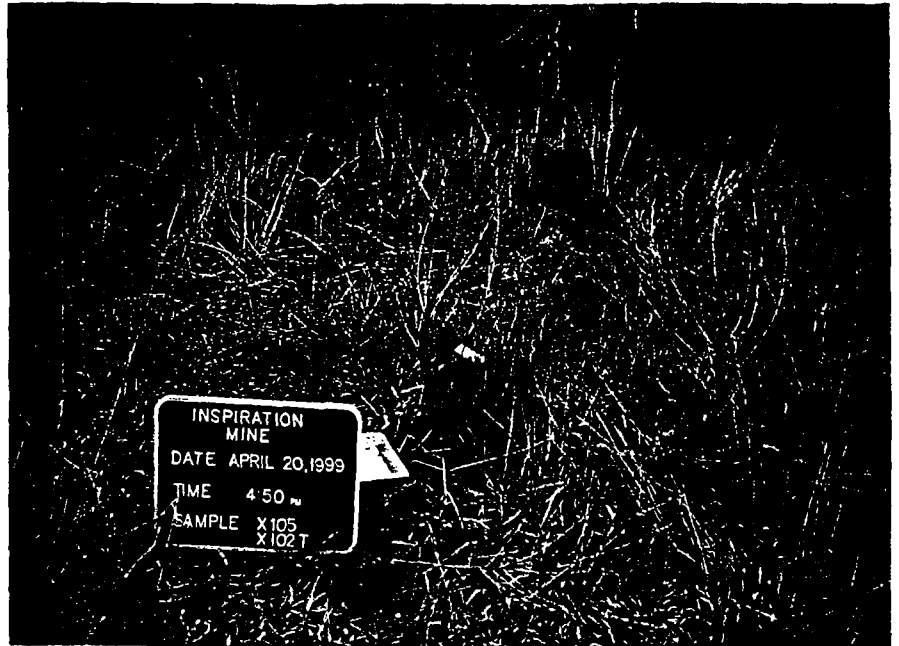
**COMMENTS: Photo taken
of soil sample near
former process area.**

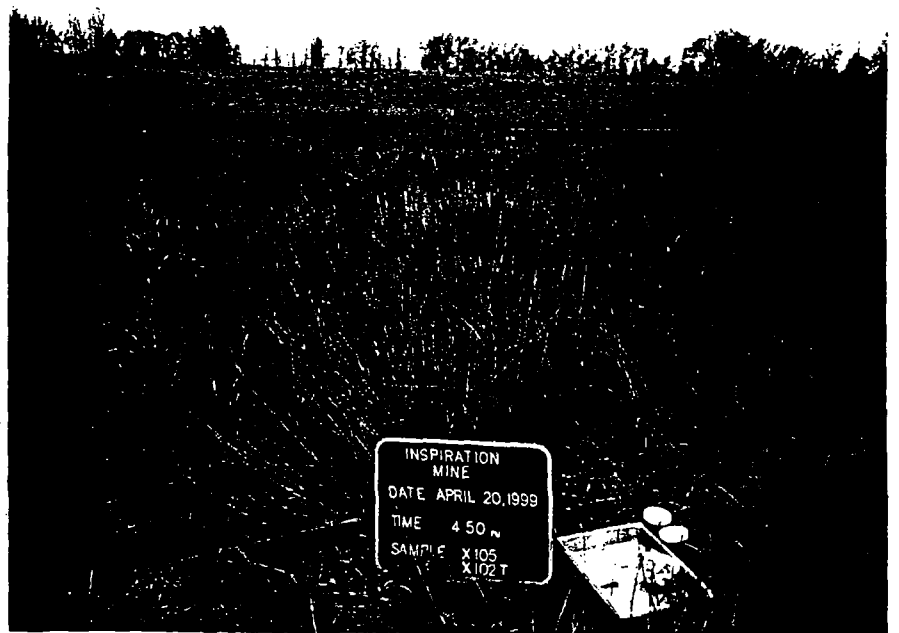
**COMMENTS: Photo taken
of soil sample near
former process area.**

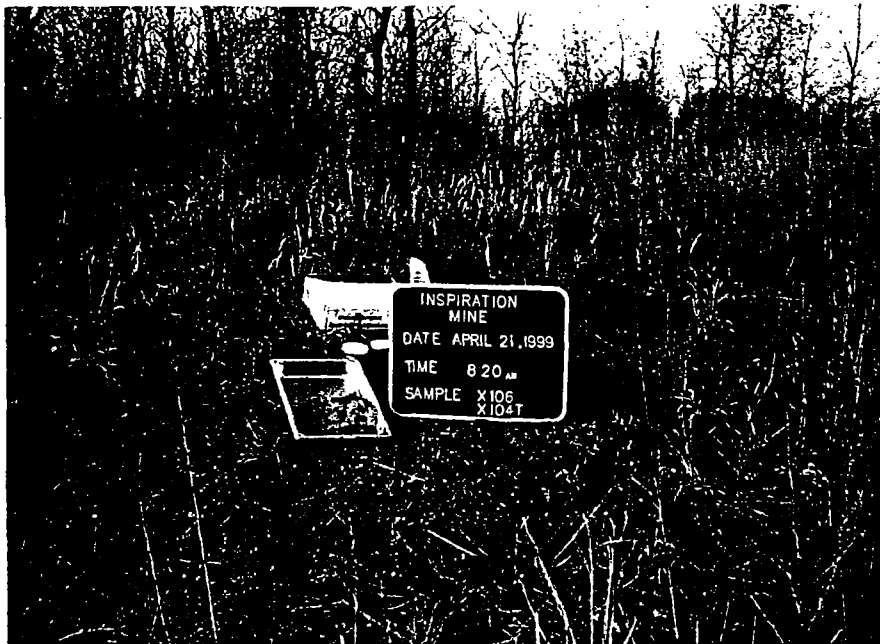
COMMENTS: Photo taken of soil sample point located on berm of recontoured tailings pile.

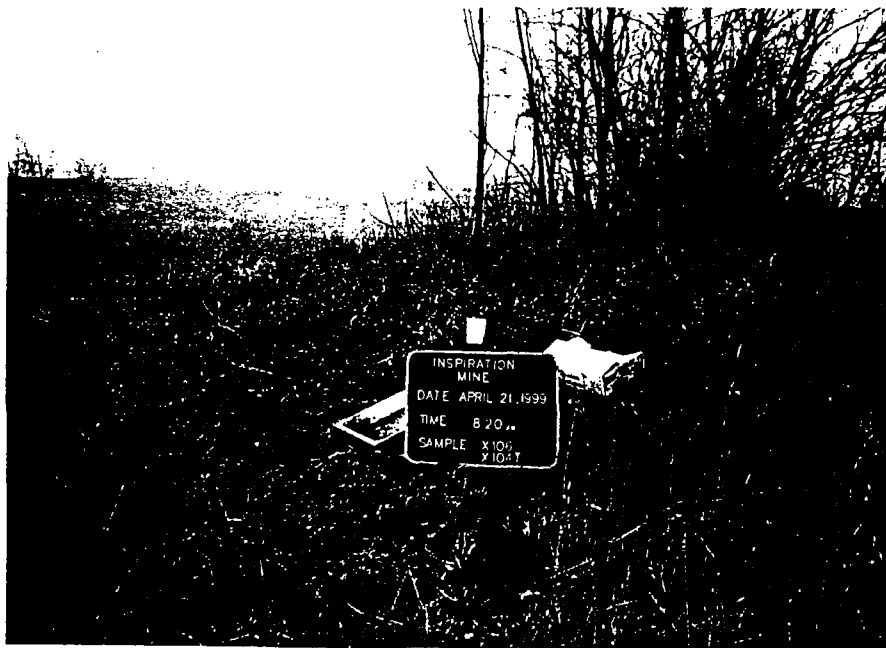
COMMENTS: Photo taken of soil sample point located on berm of recontoured tailings pile.

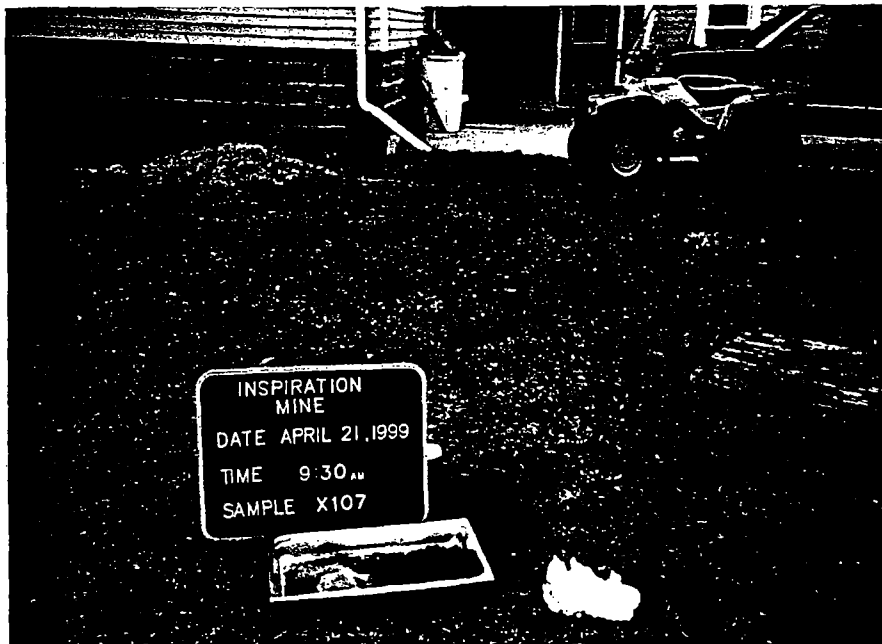
COMMENTS: Photo taken of soil sample collected from residential yard west of mine.

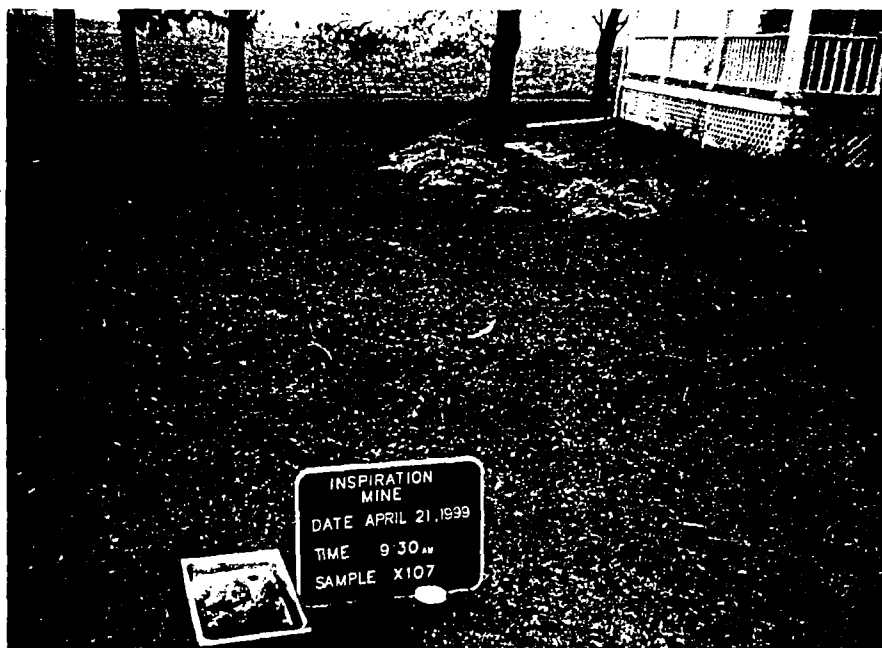
COMMENTS: Photo taken of soil sample collected from residential yard west of mine.

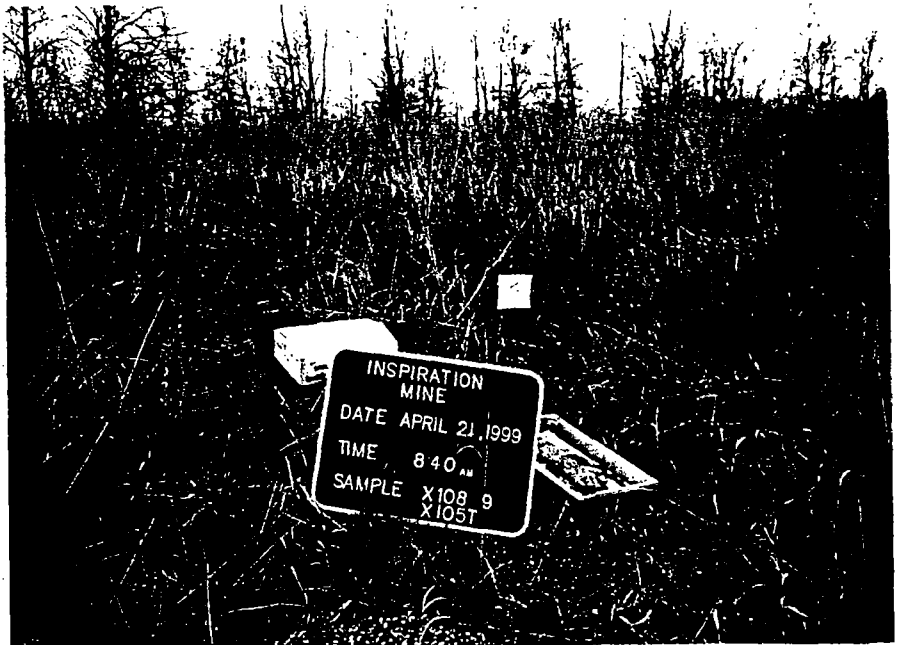
COMMENTS: Photo taken
of soil sample
collected from
southern portion of
recontoured pile.

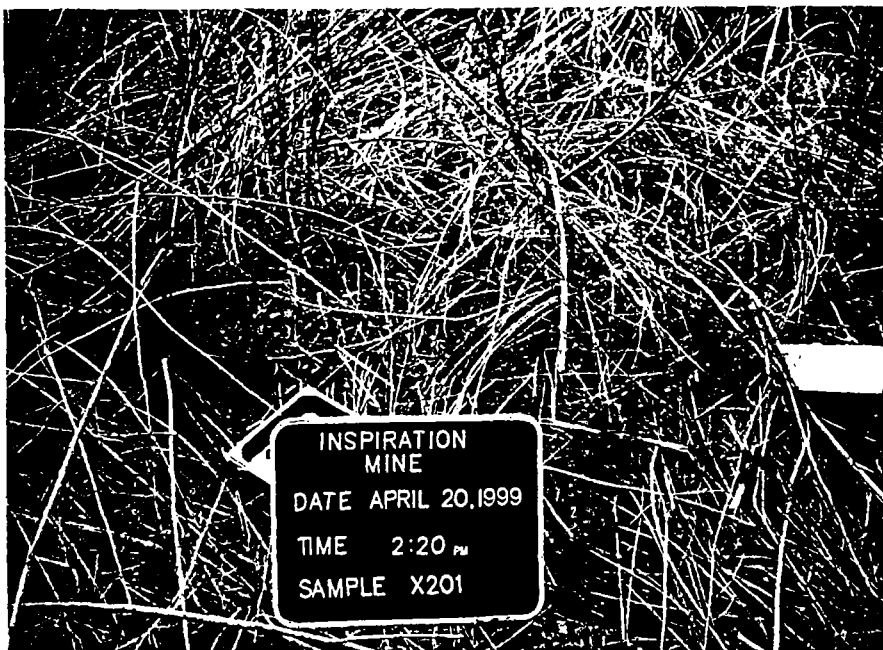
COMMENTS: Photo taken of sediment sample collected in the unnamed tributary north of the former pile.

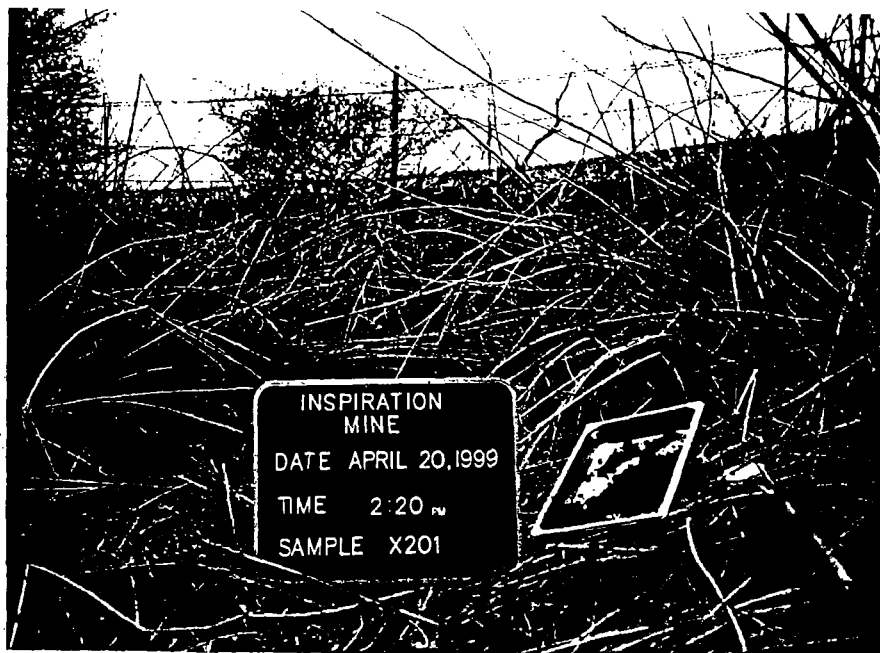
COMMENTS: Photo taken of sediment sample collected in the unnamed tributary north of the former pile.

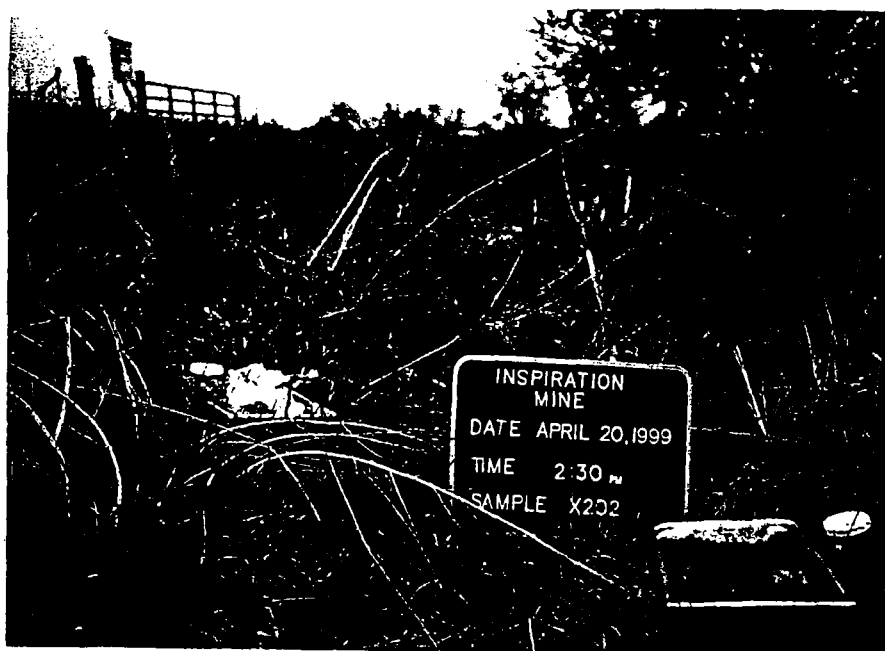
COMMENTS: Photo taken of sediment sample collected in the unnamed tributary north of the former pile.

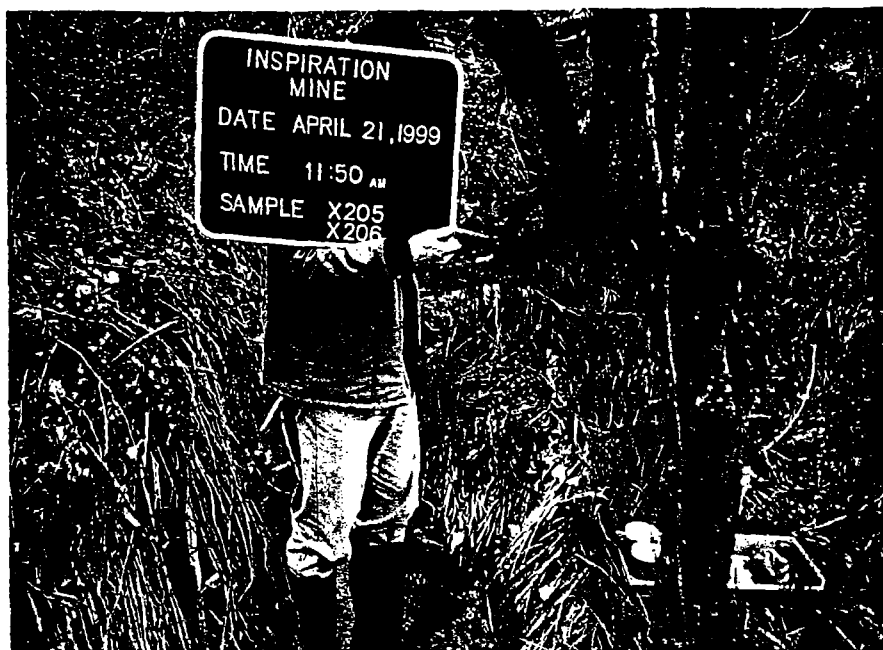
COMMENTS: Photo taken of sediment sample collected in Millbrig Hollow east of Meridian Road.

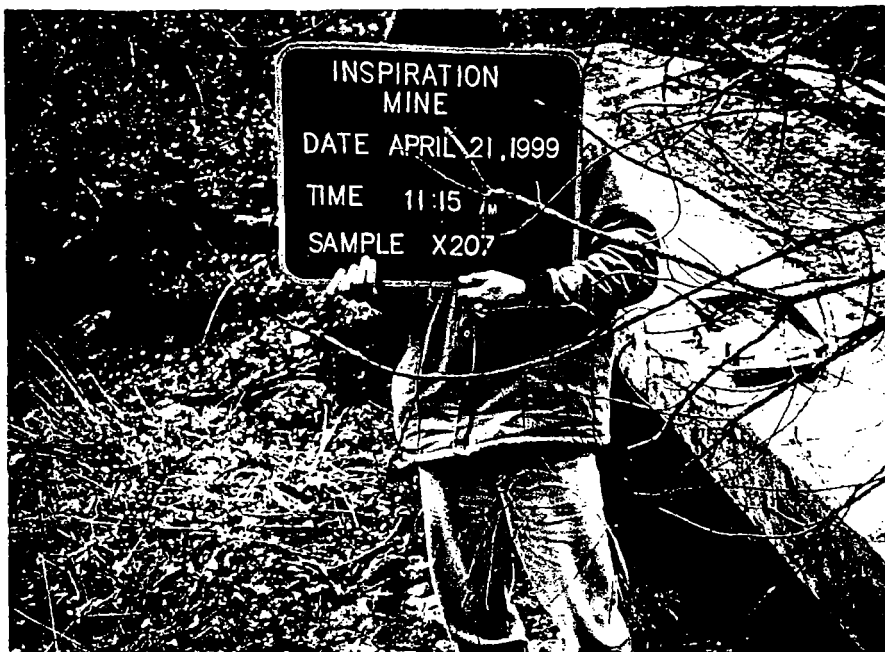
COMMENTS: Photo taken of sediment sample collected in tributary to Millbrig Hollow, SE of mine.

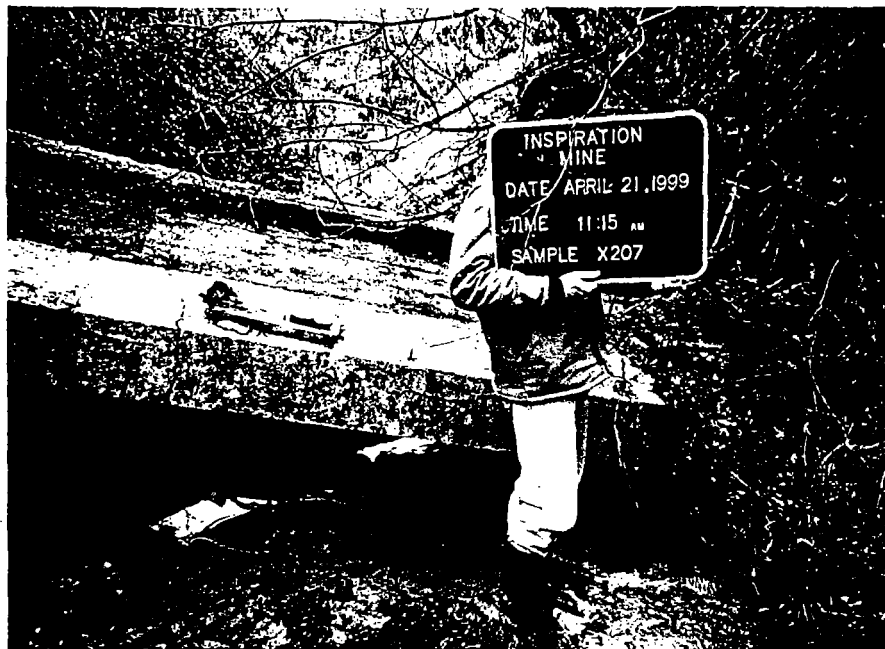
COMMENTS: Photo taken of sediment sample collected in tributary to Millbrig Hollow, SE of mine.
